Re: May 2012 Monthly Progress Report  
Administrative Settlement Agreement and Order on Consent for Removal Action  
U.S. EPA Region 10 Docket No. CERCLA 10-2009-0255  
Gasco Sediments Site within the Portland Harbor Superfund Site

Attachment A      Monthly Visual Monitoring Report for Pilot Cap Vicinity

## Visual Observations Log Form

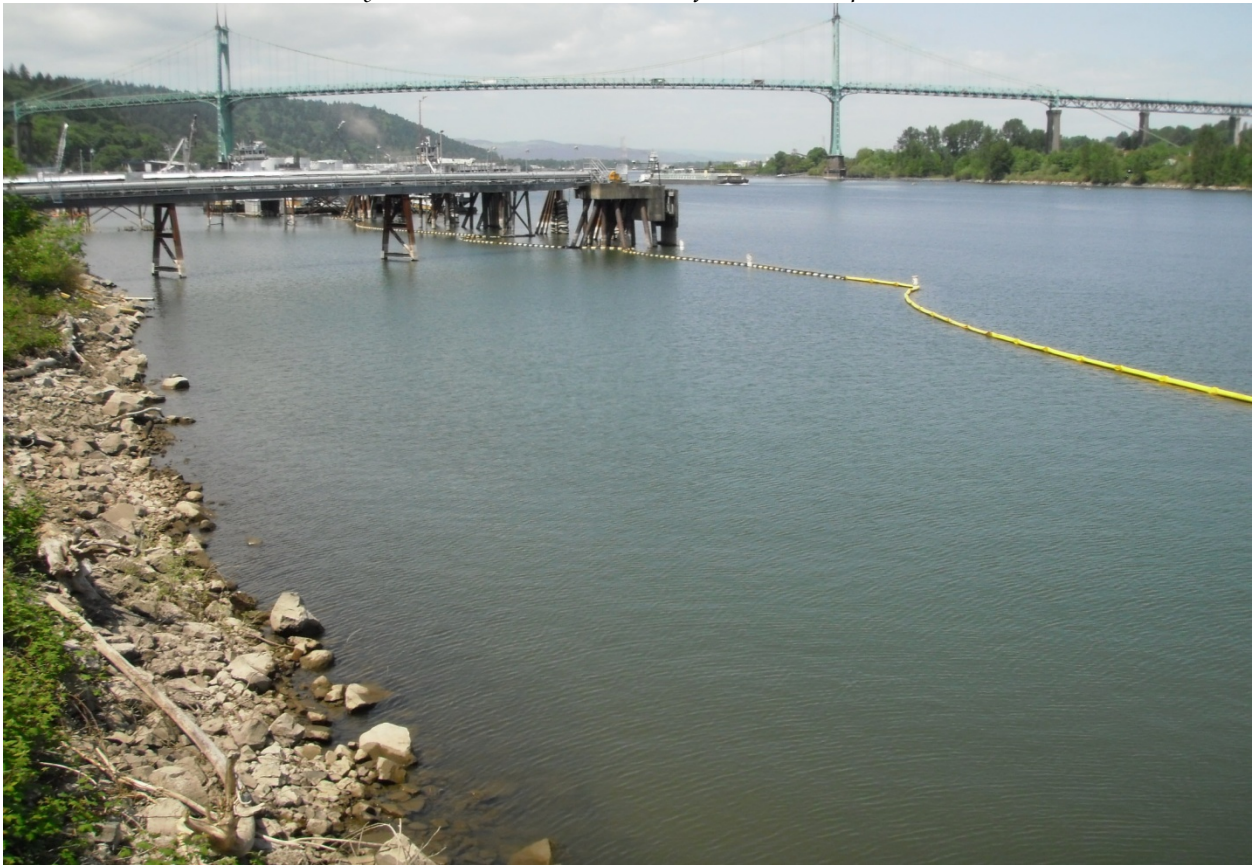
Photo 1 — *River level currently elevated above the extent of sediment cap (5/17/12):*

**Observations of Erosion/Deposition:** No erosion/deposition is evident along the shoreline. The shoreward extent of the cap was not visible due to high river water elevation; and the extents of the organoclay mat material were also submerged. (Photo 1).

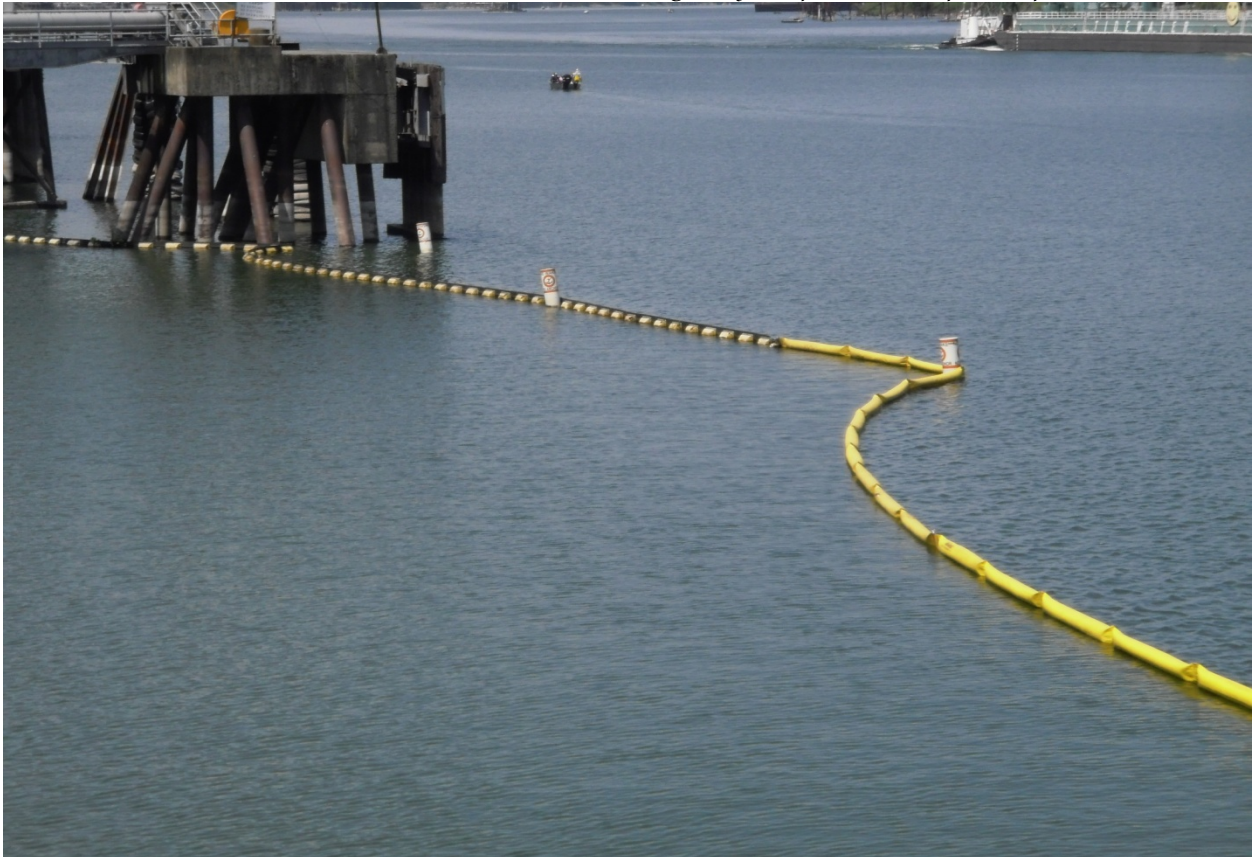
Photo 2 — *FAMM oil boom shown and mariner warning buoys in place across pilot cap area. (5/17/12):*

**Observations of Long-term Controls (i.e., oil booms, organo-clay mat, etc.)** During the observation, the Fuel and Marine Marketing (FAMM) containment boom was placed across the cap area, between the upriver corner of the ship dock and the wooden dolphin (near the upriver extent of the site and near the Siltronic Corporation outfall). Buoys that identify the cap area to mariners are in place as installed. The position of the FAMM oil boom, warning buoys, and a general overview of the site shoreline is shown in Photo 2.

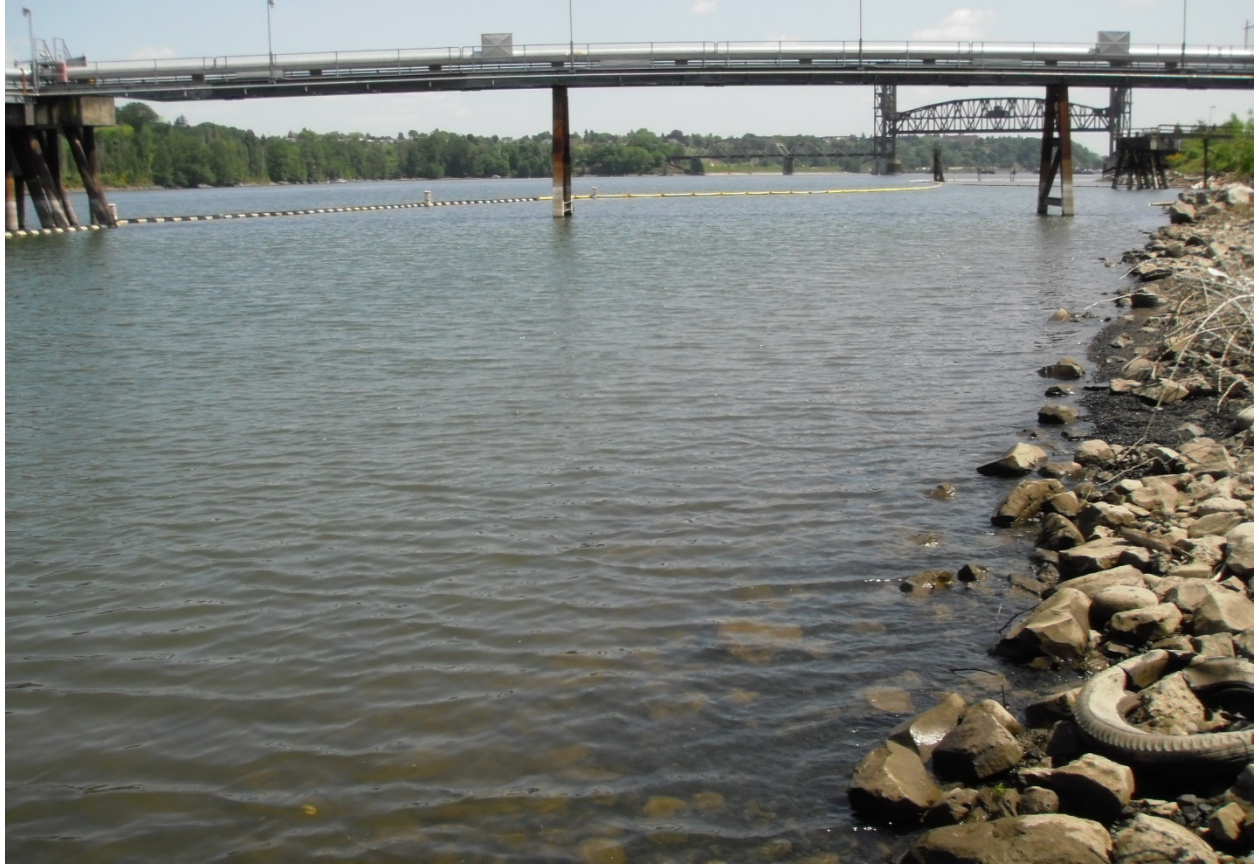
Photo 3 — *Conditions immediately downriver of cap area (5/17/12):*

**Other Comments:** No sheen is evident in or around the cap area. Photo 3 shows the water surface and shoreline immediately downriver of the sediment cap.
